Founded 1979 Incorporation No A6677 P.O. Box 692, Shepparton 3632
November 2020

This is part 3 of Denys's article on the Codan 8525 modifications to make it quite versatile. Please note that the information follows on directly from last month – my splitting of the article in several parts could have been better – Sorry Denys (Editor)

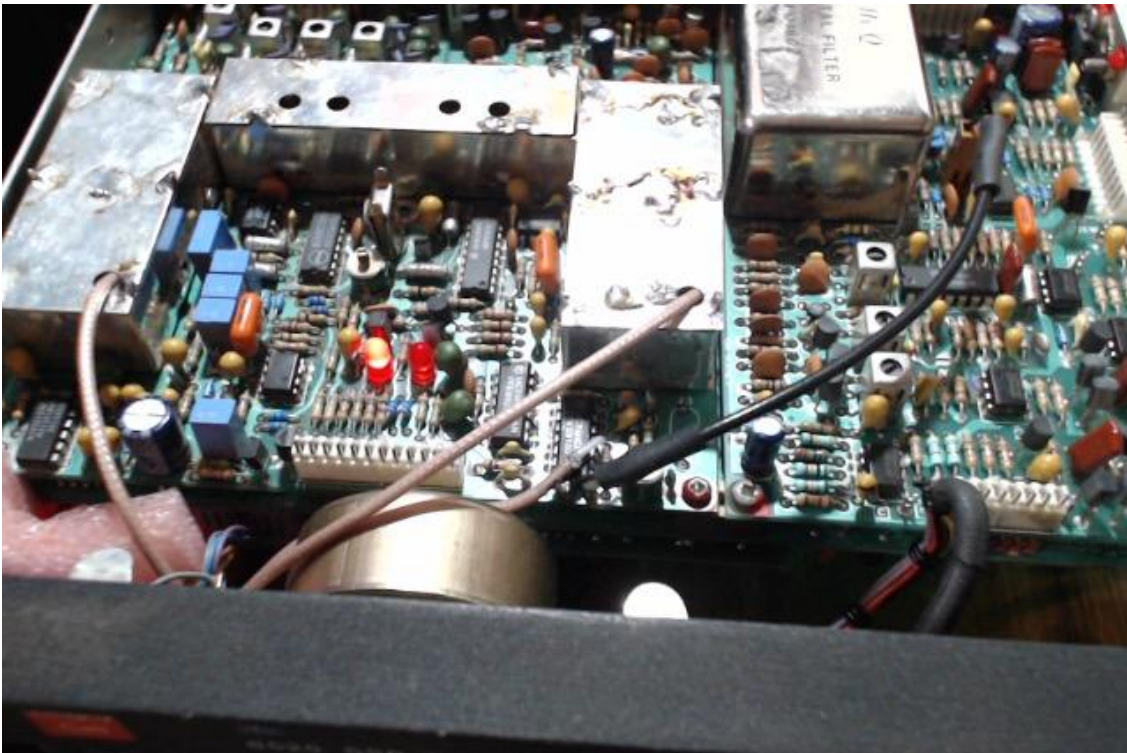
Re-install the board, but take care to get the pins into the holes from under the PCB. It can be a bit tricky.

The board will now look like this.

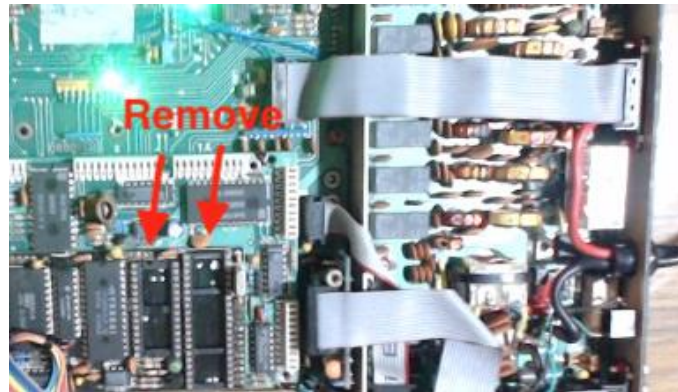
Now, remove the CPU and EPROM if you have not already done that, and store them in some anti static foam in a safe place.

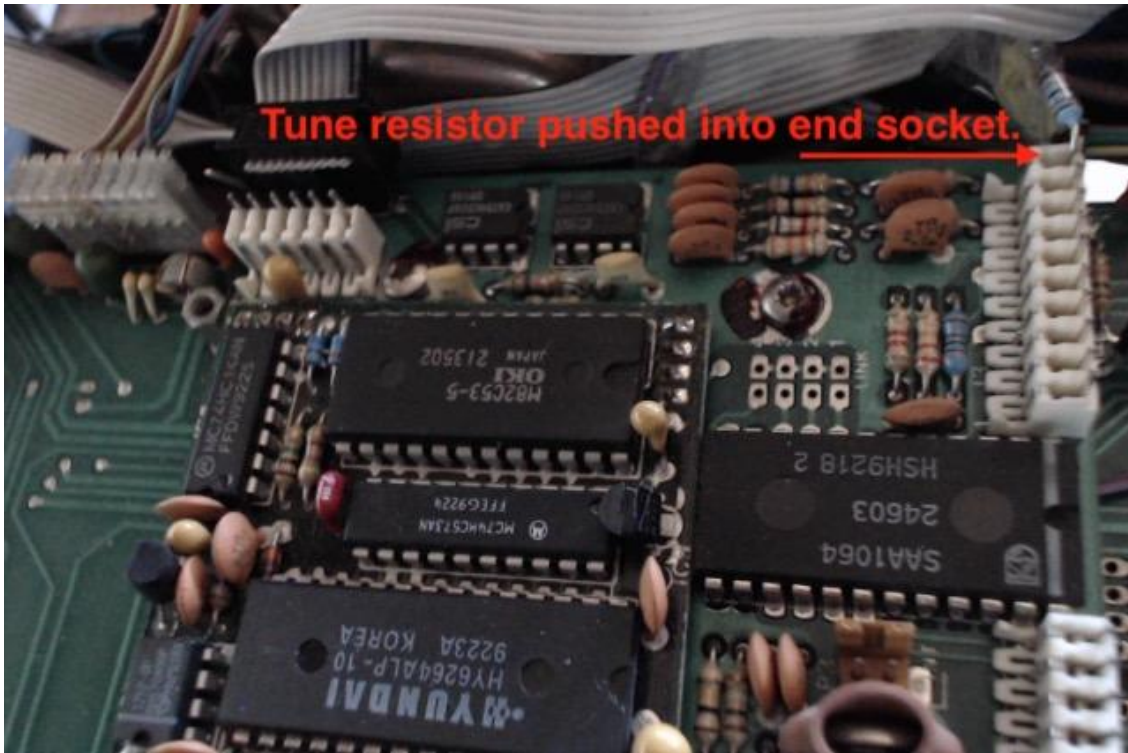
There is wire running from the VFO to the Codan controller board for the Tune signal. It is just pushed into the connector as below.

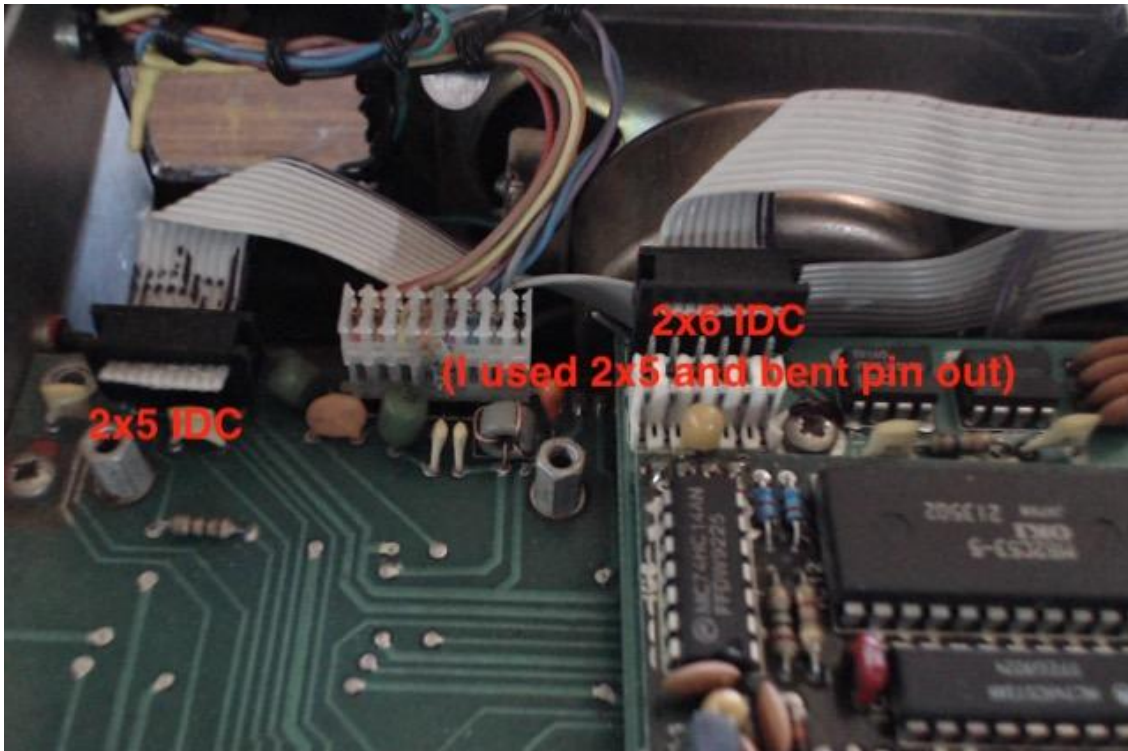
Connections from the VFO board back to the Codan are all on the 2x10 IDC lead. This is split to one 2x5 IDC plus that goes to the Codan main board "P5", and a 2x6 IDC plug for the Codan "P1" (The picture shows a 2x5 and one pin bent out off the way as I did not have a 2x6 IDC plug handy).

Here is the overall view, showing the 2x10IDC and the Codan keypad connections. **The final part of Denys's article will follow in the January issue of the newsletter.**
