Canadian Vintage Radios

Winter 2025 Issue

Another 'Set From Hell' - a Howard 329-619 'Sussex' – Marcus Chick (Vintage Radio Club of NE Victoria, Australia)

Restoration of an RCA Radiola IIIA—Larry Tell

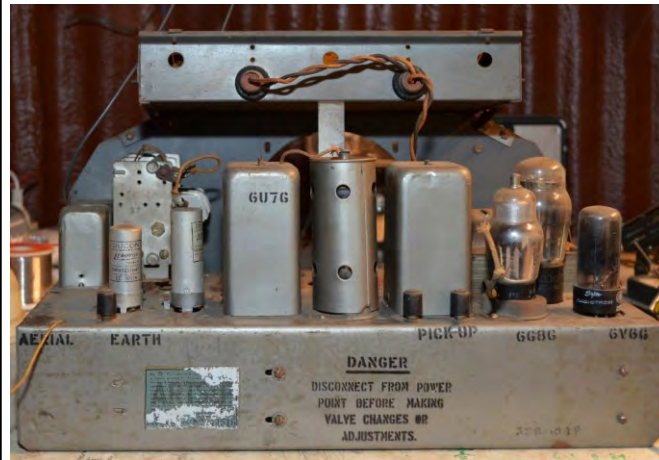
After some searching, I found out that the Howard chassis presented to me to attempt to fix (photo, below), was in fact manufactured by 'Regent Radio Pty Ltd.' according to the 1937 'Trade Annual'. They were located in Burke Road, Camberwell, and were manufacturers of all types of radio receivers, public address amplifiers and transmitters. While that was all wonderful, it made no real contribution to sorting it out.

From the initial assessment, it fortunately looked like it had only two cathode electrolytics replaced and the originals, left under the tag board Cont. on Page 16

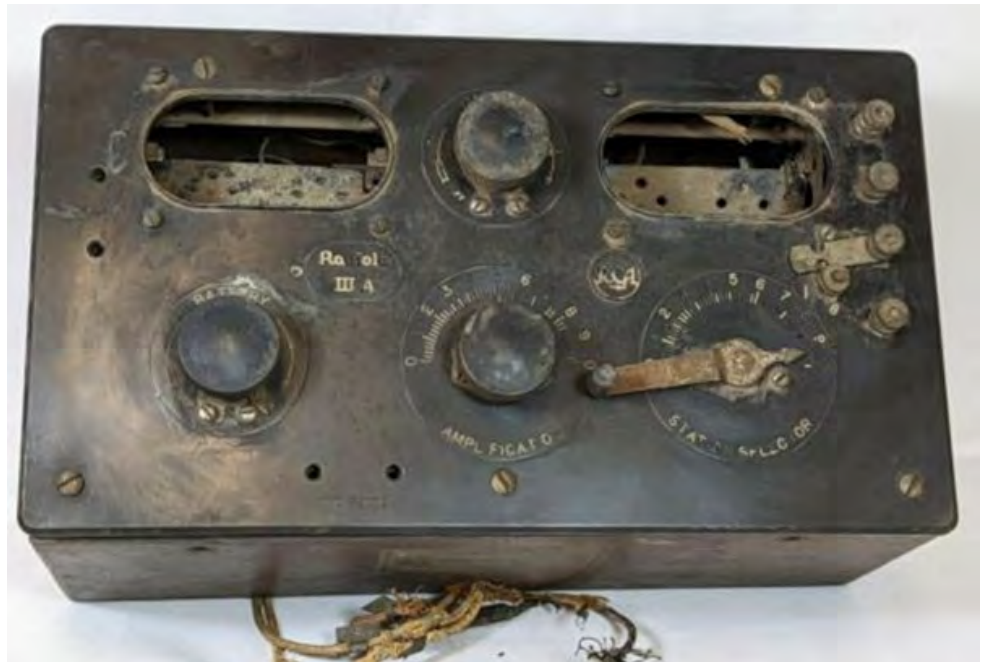
As can be seen from the photo, right, my Radiola IIIA needed a lot of work, including:

- Replacing core and coil of all three interstage transformers;
- Replacing tube socket supports;
- Replacing wire to moving coils;
- Replacing tubular capacitors;
- Replacing main cable;
- Adding WD11 kit tubes;
- Re-plating all visible metal parts;
- Replacing thumb screws;
- Replacing most front panel screws;
- Applying black shoe polish on the front panel;
- Using white filler stick on all engraved lettering and scale; and
- Applying paste wax on cabinet

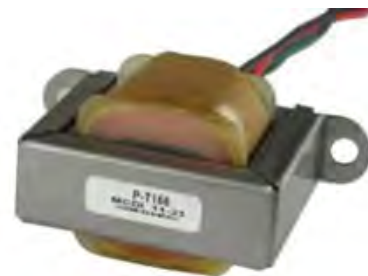
The two interstage and the output transformer were all open-circuit. I chose to replace them and used Hammond PT-156 (photo, right). I modified the metal band around the core and mounted the transformer in the shell from the original transformers. Since the Hammond core is smaller than the original core, there is some visible difference, but from the side the transformers look original. The PT-156 is available from the [Antique Electronic Supply](#), who offer some alternatives, and other alternatives are available on a search.

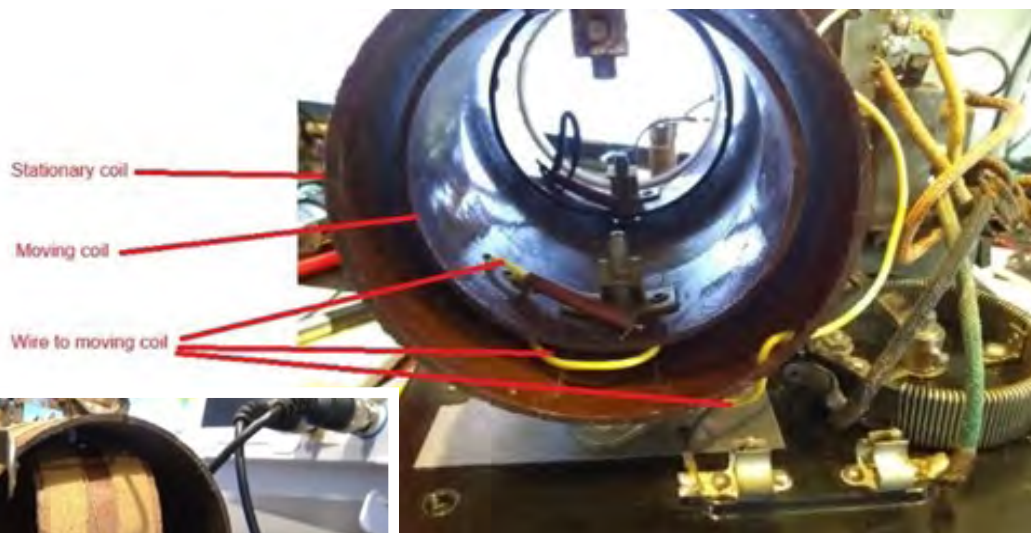
Both radios are tuned with variometers consisting of

coils that rotate about 90 degrees withing a larger fixed coil. A flexible wire connects to one end of the rotor winding while the other end is connected through the support shaft (annotated photo, right). The flexible wire always requires replacement in these radios.

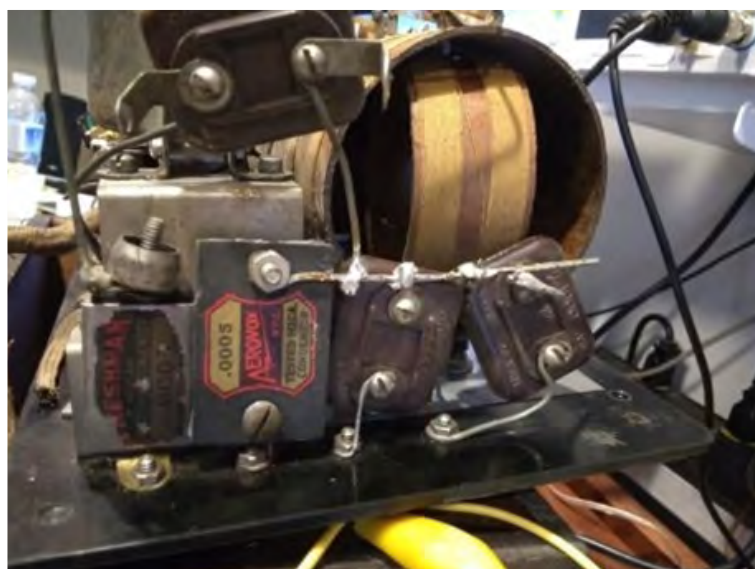
The antenna circuit is tuned

with tubular capacitors. Four inputs and a movable jumper provide tuning for a wide range of antennas. The capacitors in my radio had been replaced, rather sloppily, with 'domino' style capacitors, too far from original for me (photo, left).

To restore the radio closer to original, I found a source for firecracker tubes that were close to the diameter of the original and could be cut to the needed length. Wrapping the tubes with yellow paper brought them to the desired diameter and closely matched the original color. I was able to buy a set of damaged tubular capacitors on Antique Radio

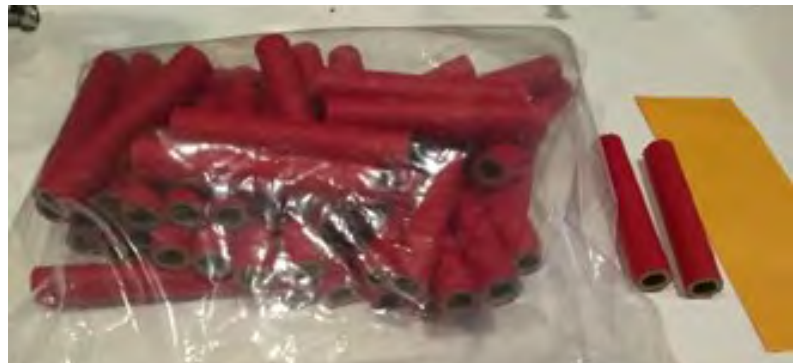
Forum and salvage the end caps. Modern capacitors were soldered to the end caps and mounted

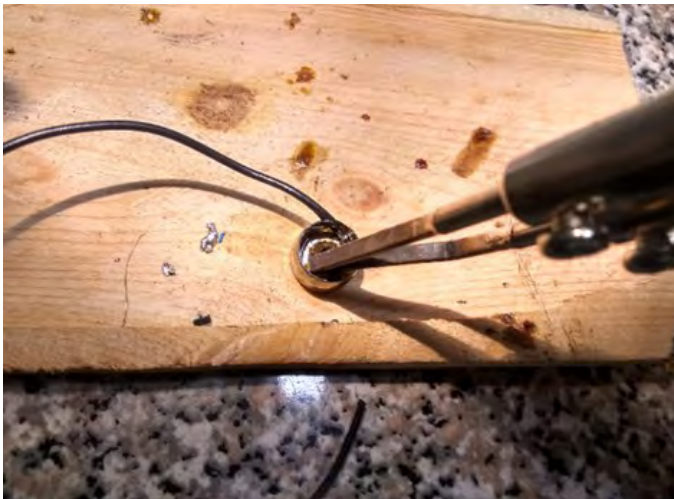
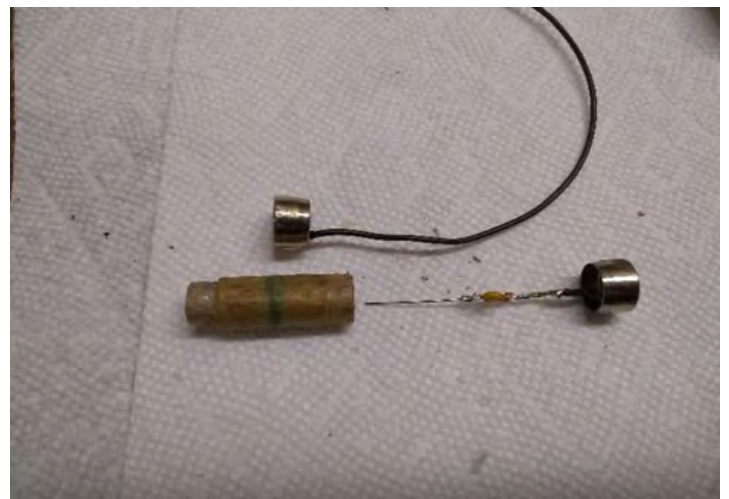
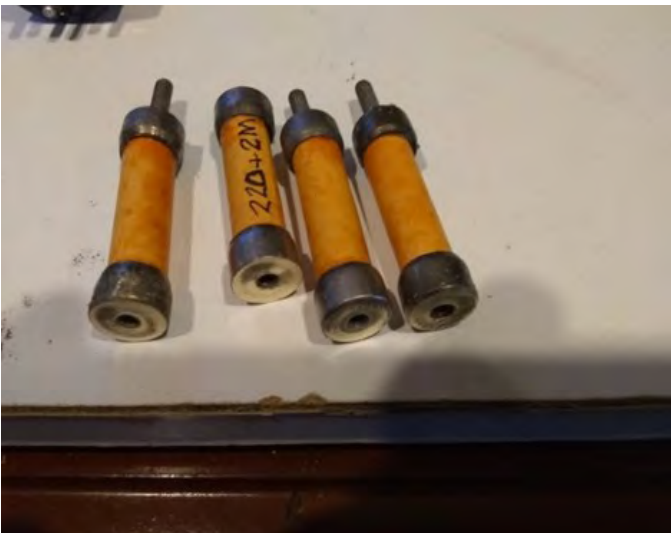
inside the firecracker tubes then the end caps glued to the tubes (photos, above and left) - *[these look great! - Ed.]*

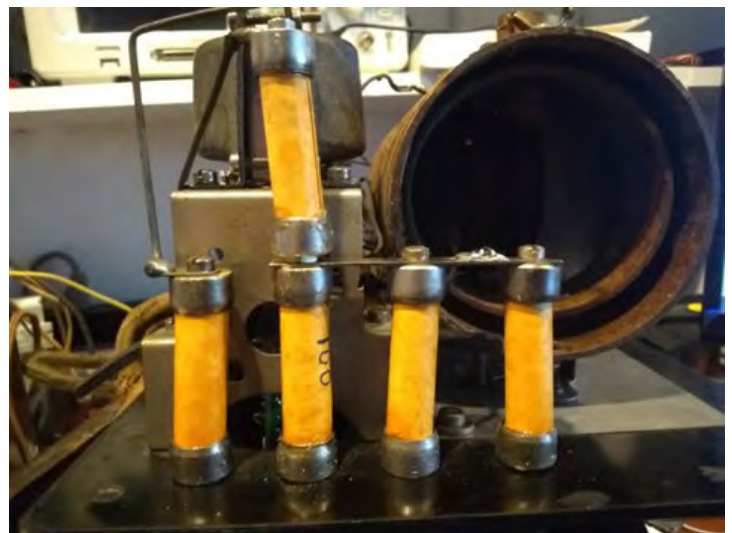
Once mounted in the radio they made a reasonably good match to the originals (photo, below).

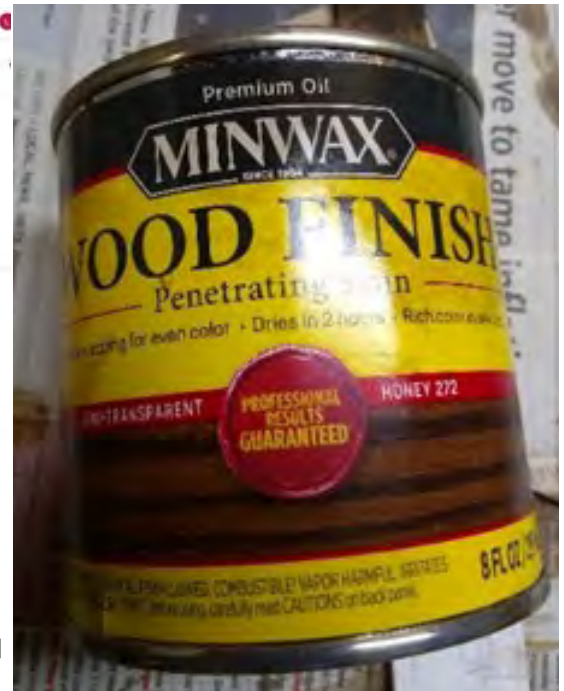
badly frayed and beyond salvage. I found a modern cable (www.colorcord.com), but it was not available in the brown of the original so I chose the white option (photo, top left on page 7).

I tried to dye the cable with RIT dye but was not satisfied with the result. Then I tried Miniwax wood stain

(photo, right) with good results. The cable is a good match to the original except for the exposed conductors at the ends. Possibly some cotton covering could be added over those wires but the cable, as shown in the photo, below, is acceptable to me.

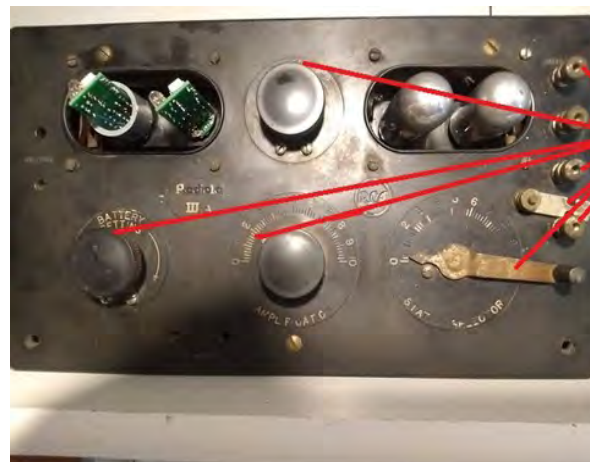
Parts to be plated

The metal parts were all corroded and stained (annotated photo, right). I didn't want to mess with the solutions required for replating, so found a plating house to do the job - 'JR Plating' ('JR'), located near me (39374 Grand Ave. North Branch MN 55056 651-464-0761), was very helpful and responsive and did a very good job of replating the parts of both the Radiola IIIA and my earlier Radiola III, although it took about 4 months. I initially planned to have the threaded parts replated but JR warned

Plus all screws approximately 20

Original plating was said to be Nickel. I'm open to recommendations

that the threads would be filled in and unusable so only the unthreaded parts were replated.

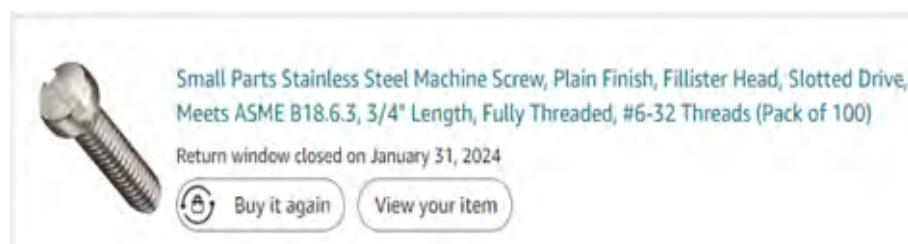
Threaded parts were replaced with new parts readily found on the internet (see image, left).

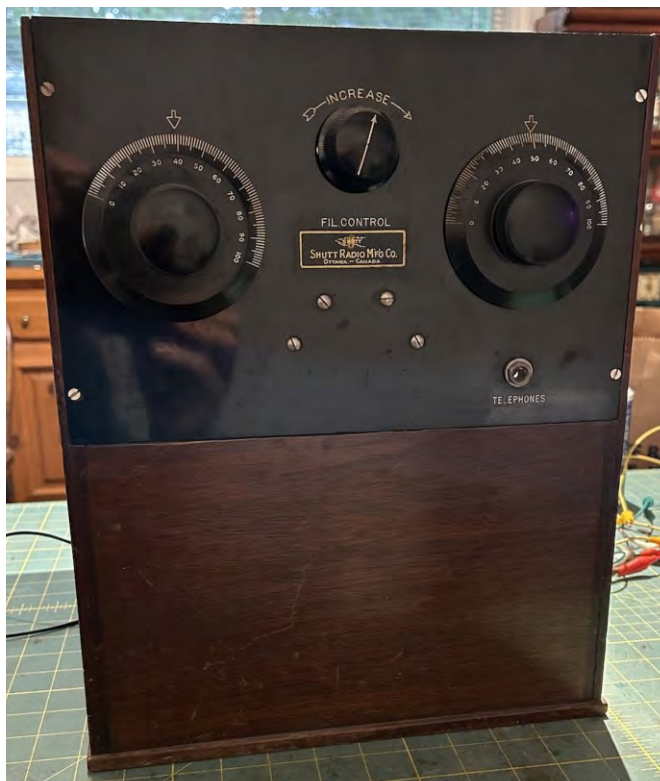
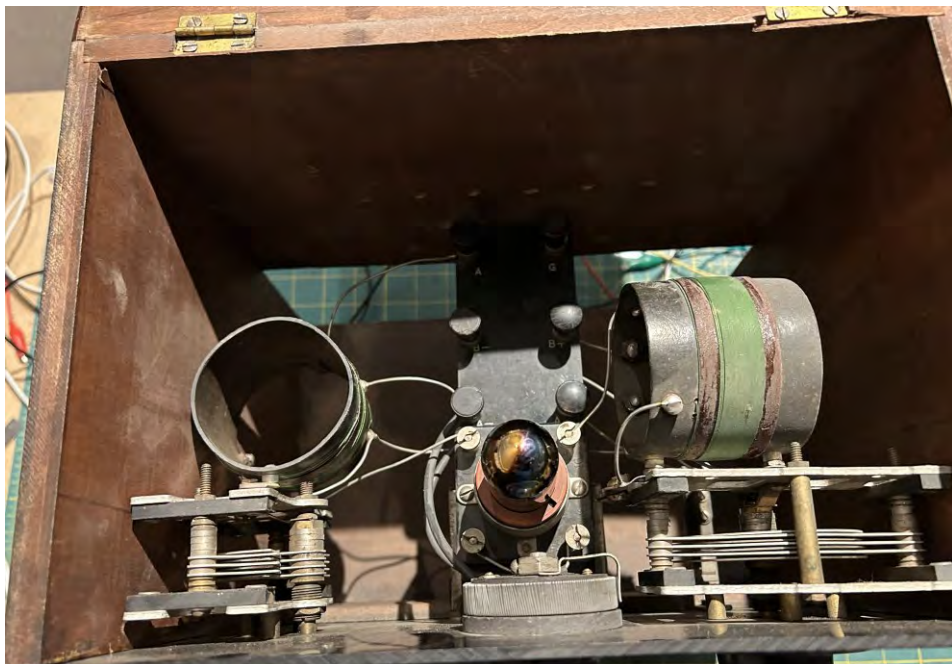
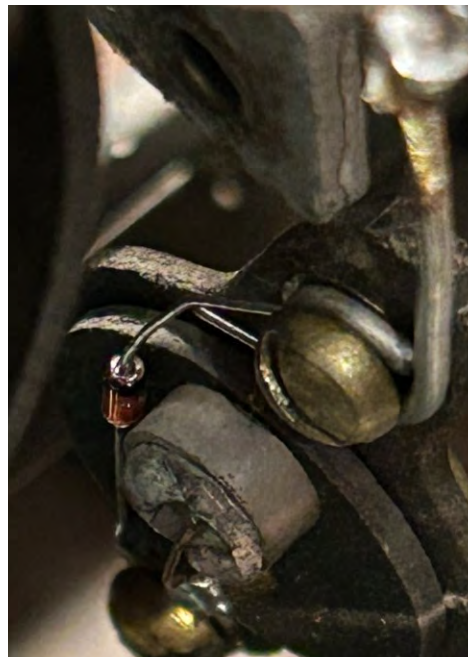
I found that the only real problem was with the crystal detector (photo, below right) that was very weak. Rather than attempting to rebuild the detector, I attached a 1N34 diode across the terminals. This worked perfectly.

I applied 3V 'A' supply and 22V 'B' supply, and using my trusty Dixie Cannonball headphones, I was able to pick up two stations in Vancouver. Reception was surprisingly strong for this type of radio.

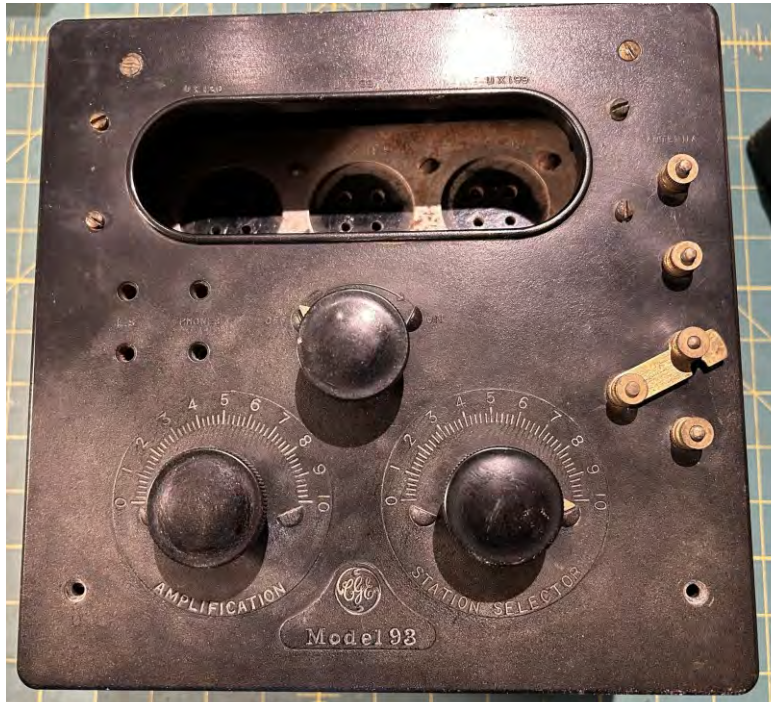
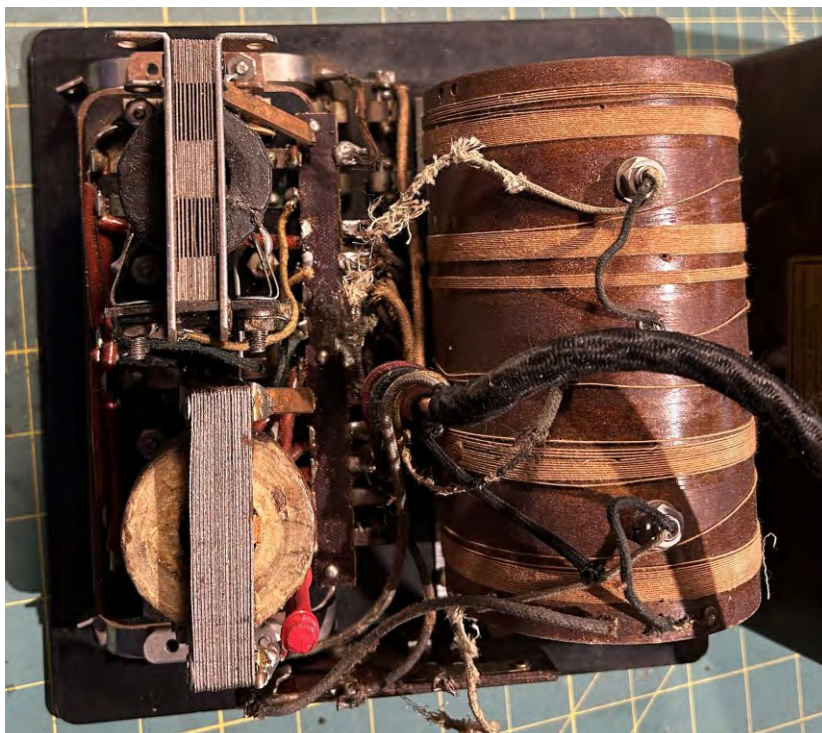
- The radio was very dirty and lettering was faded (photo, right);
- Mouse damage: they ate the cloth insulation off of the wires (photo below);

- One incorrect transformer had been installed at some time in its life and it was not properly mounted (photo, left);
- Both transformers were open-circuit;
- Lead wires were broken for the 'Amplification' and 'Station Selector' rotors in the tuning assembly (photo, left);

I started with the Catacomb assembly which contains the tube sockets and transformers. First, I de-soldered and removed this unit from the face plate. The cover on the catacomb was unbolted, the mouse debris was removed and everything was cleaned. I went through my pile of parts and was able to get together enough parts to make two identical transformers. The windings on both transformers were open, so I replaced them with replacement coils from Antique Electronic Supply. I have used these P-T431 coils in other Radiola sets, and they work fine (photos

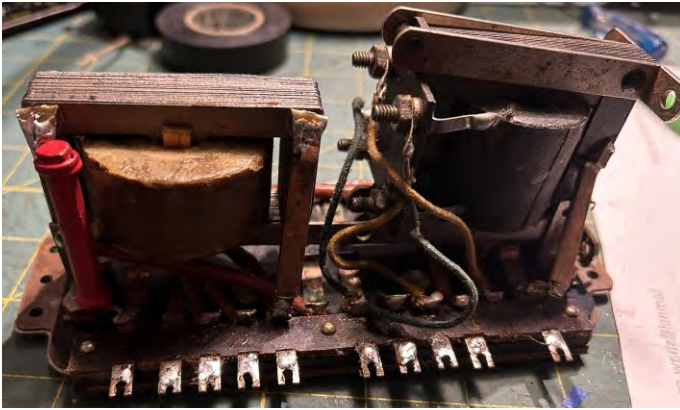
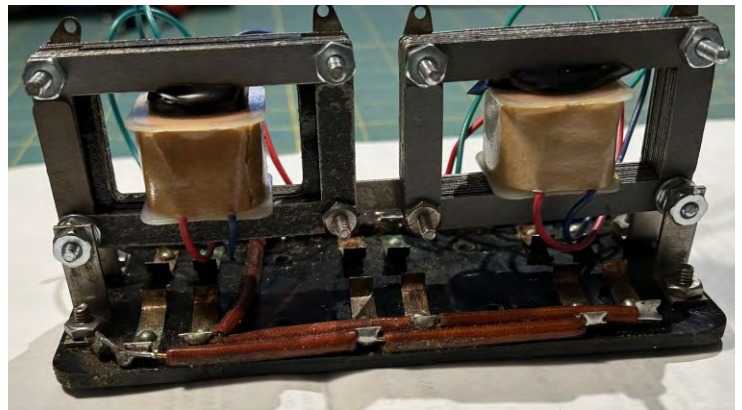
Next I removed the rotors from the coil assembly. I rewired the rotors and reinstalled them. I also replaced all of the other lead wires from the coil assembly, output jacks and the antenna capacitor pack, as they were all in

poor condition. The power input wire assembly was in good condition and was therefore reused. Obviously, the insulation on the input wires was not as 'tasty' to the mice as the others (photos, right and below).

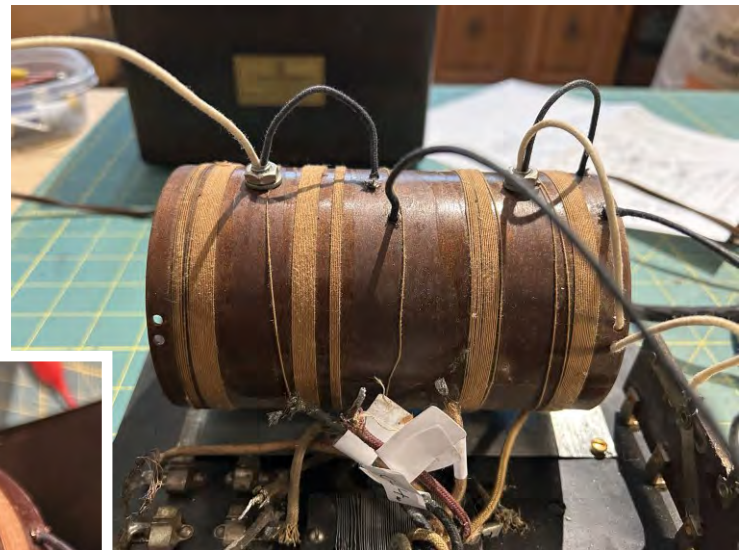
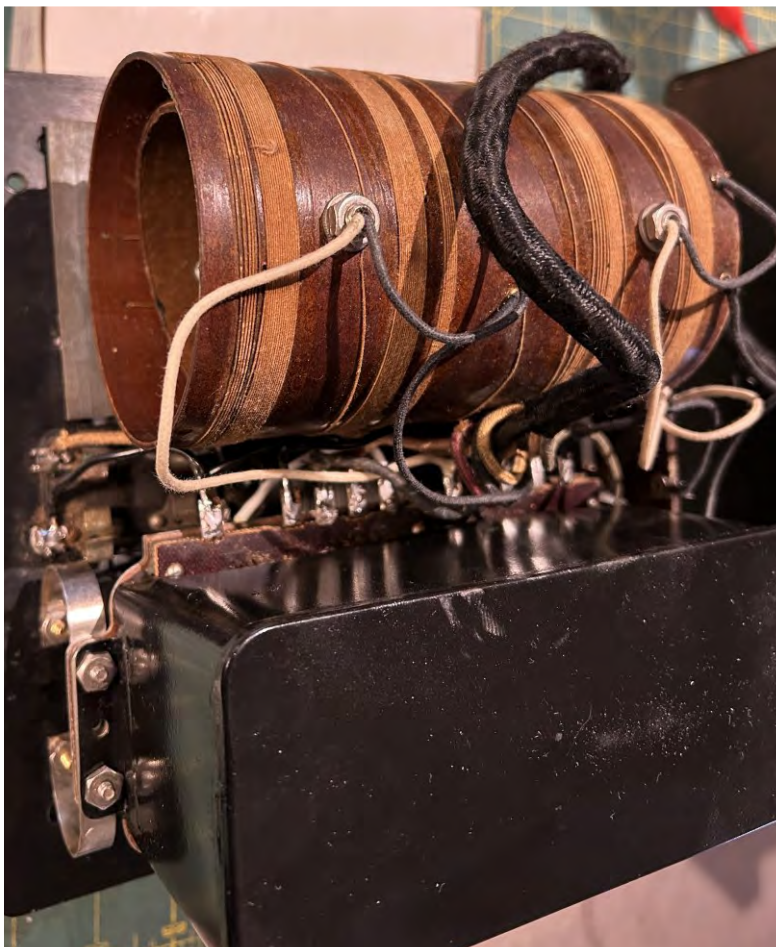
assembled. Most of the hardware needed cleaning, especially the brass parts which were black with 100yrs of tarnish (photos, page 13).

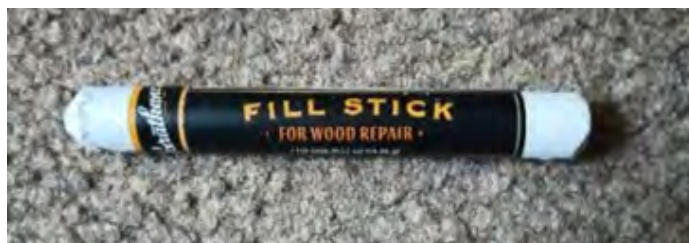
Cont. from Page 7 was disassembled with the metal parts off for plating, I used paste shoe polish on the front panel and then filled the lettering with a fill stick I found at the local Menards building supply store (photo, right).

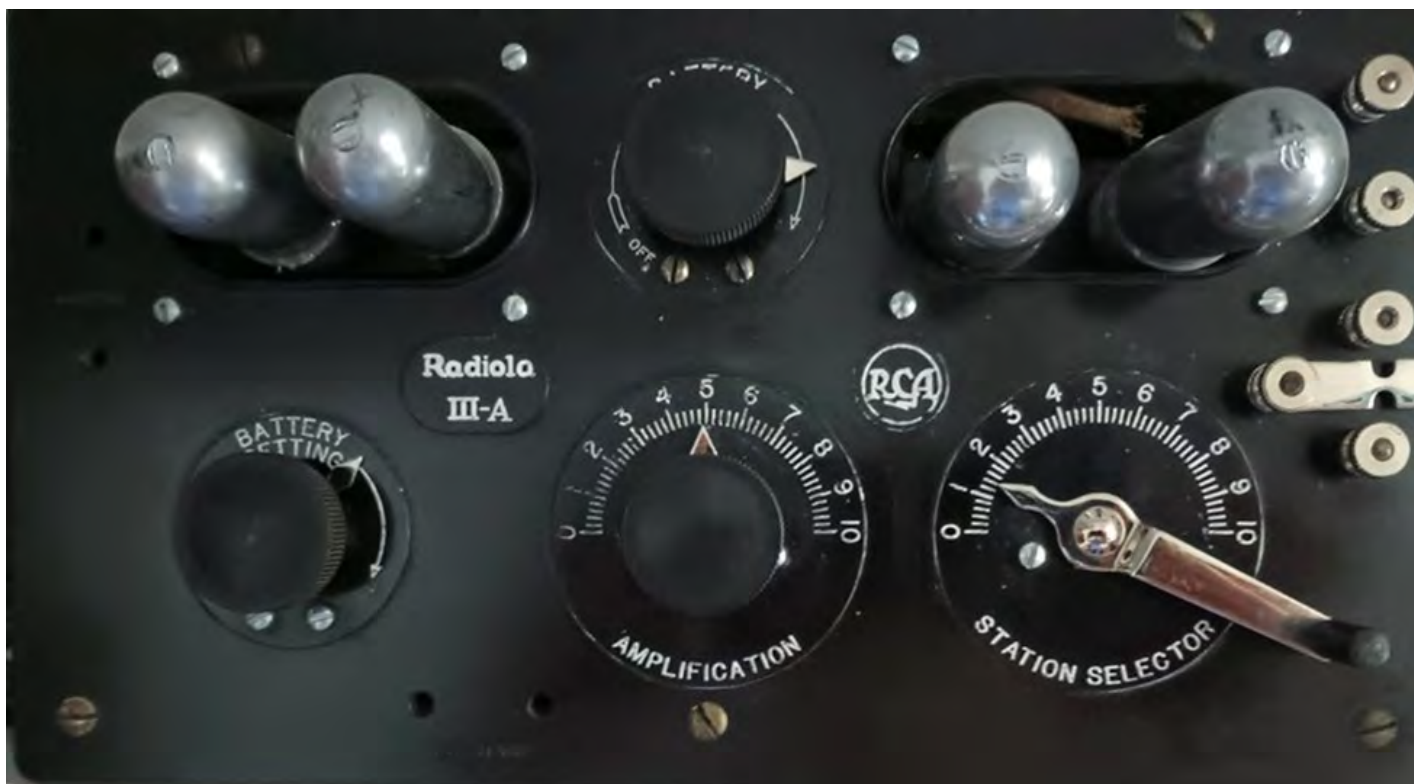
The final result is a good match to the original after 100 years. While complex to use, requiring a long wire antenna and ground along with three batteries (or equivalent), and an external speaker, and is a bit tricky to tune, the radio does work, and is a fun example of the technology of just 100 years ago. A photo of the restored radio front panel is shown below.

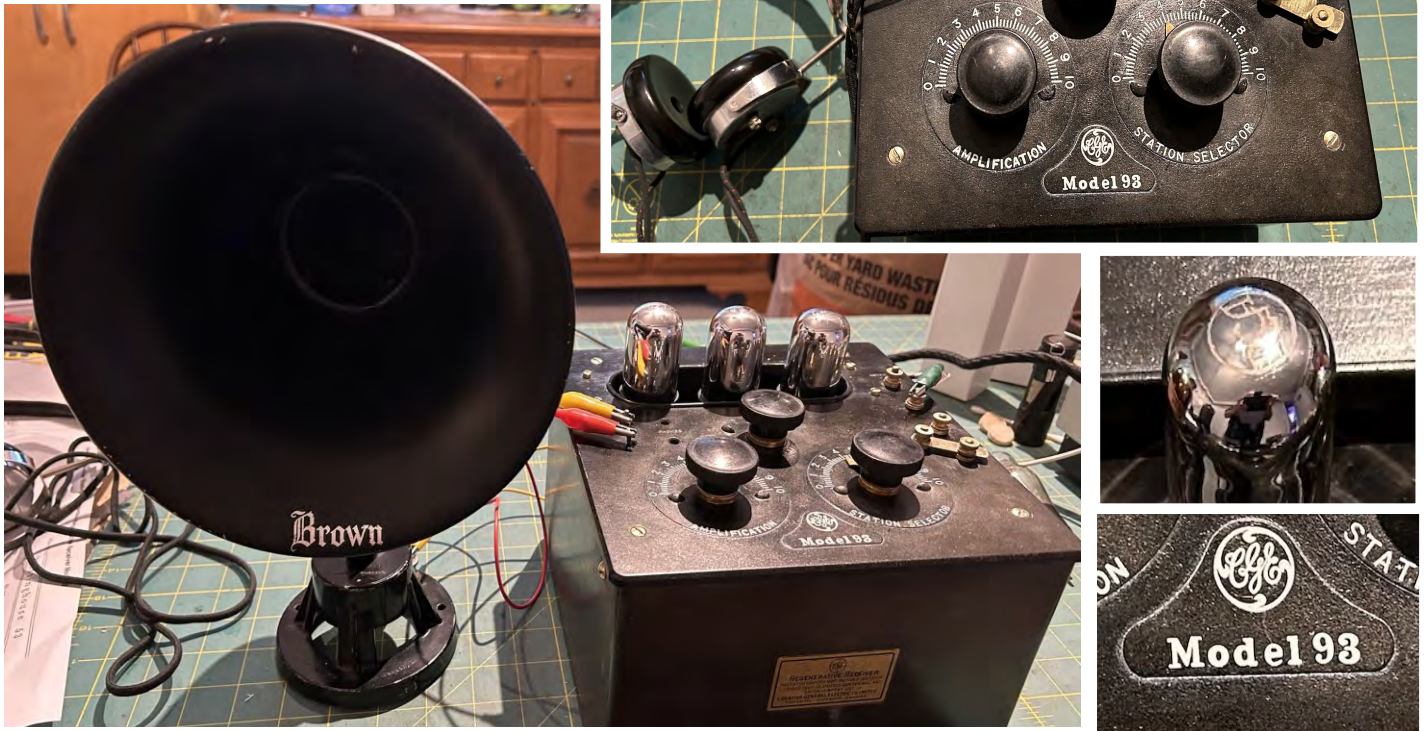
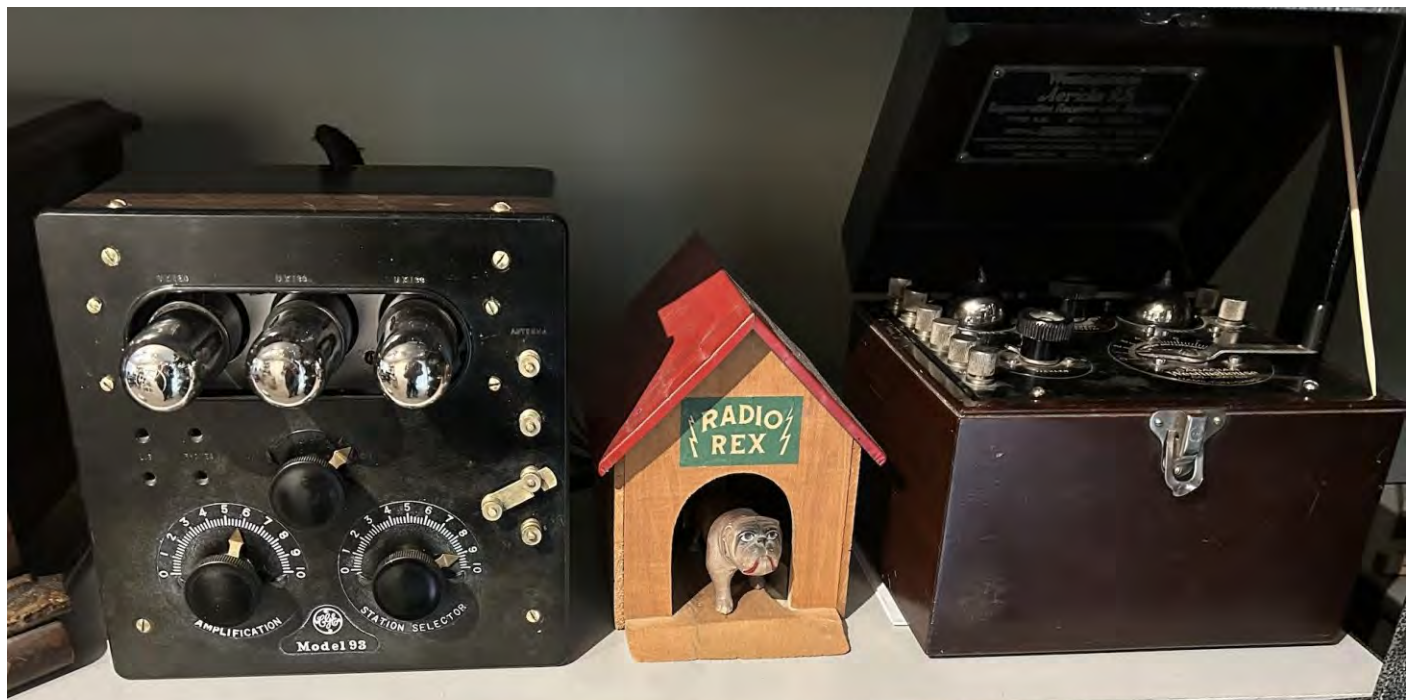
Cont. from Page 11 Brown horn. I liked the look of the CGE Model 93 with the WX12s and decided to leave them in for display (photo below).

The radio is now on display in my collection and hopefully will get taken down for some exercise once in a while. Radio Rex is on guard! (photo at bottom of page).

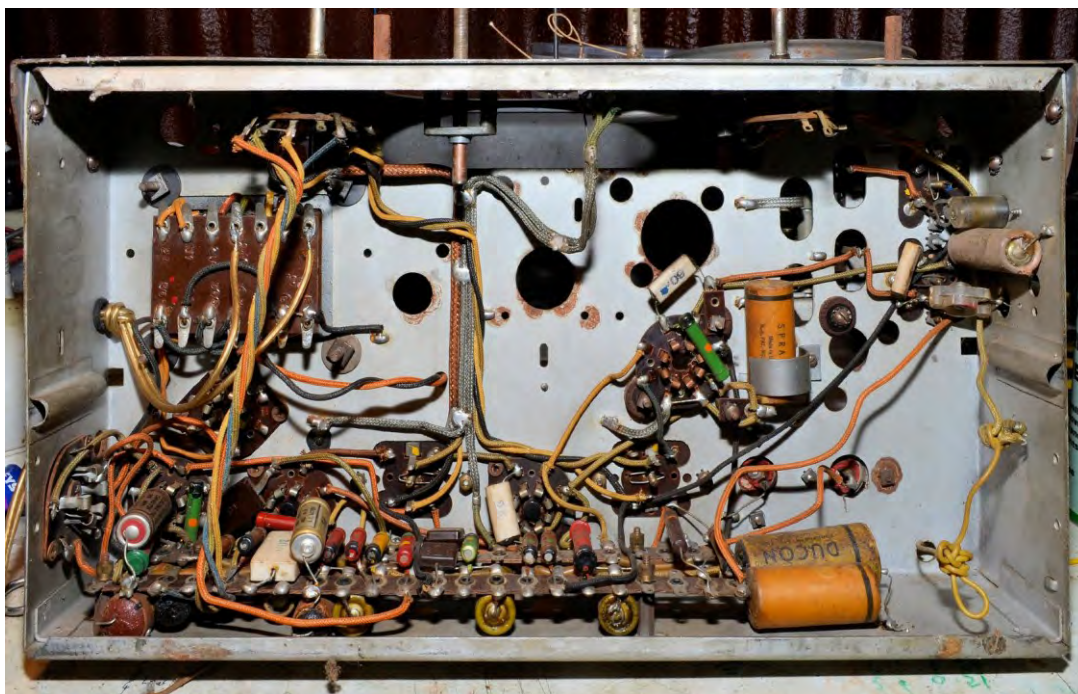
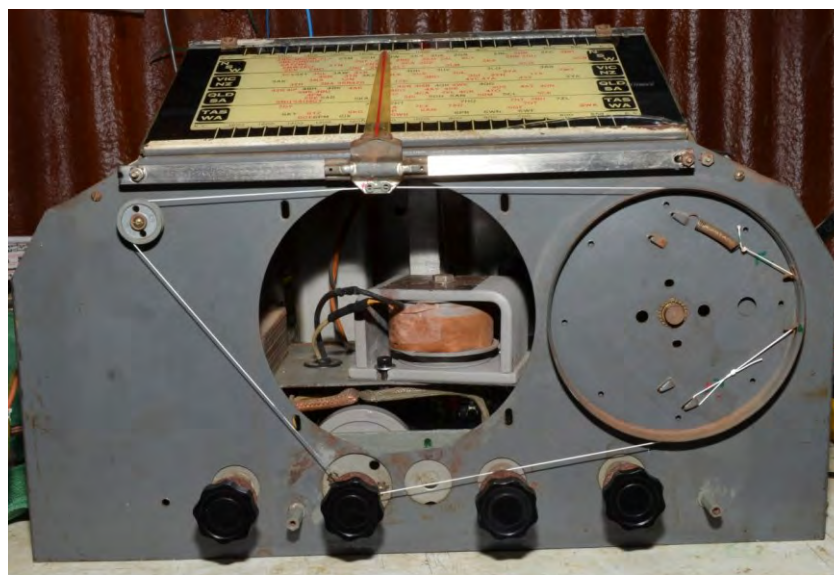
(tatty), plus one resistor. Otherwise, a broken dial cord, and the dial glass itself was cracked. The pentagrid was missing, along with the terminal of the fly lead for the 6G8 and a critical tube shield. All of the sockets were Octals: during the war there was a tendency to revert to the previous generations of old stock six pin type tubes, which I would suggest stopped 'WvD' scarpering off with them. Initially those sockets did help date it until I found the real info: but I had no schematic.

It was amusing that when rolled on its back to inspect the underside (photo, above), the inertia wheel of the tuning fell off. Its die-cast [pot metal] like most are, and will eventually disintegrate. I did paint and glue it to slow the process. It was interesting to note that the pentagrid was recessed in the chassis and it became clear that the set used to have an antenna post. That antenna area of the chassis was a bit of a 'shemozzle'.

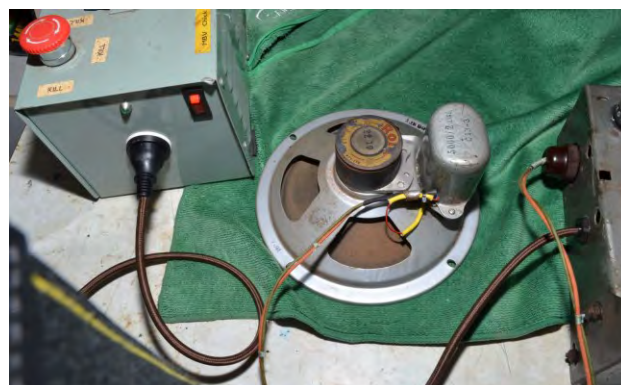
One bad habit, poorly executed, was to place a link in the speaker plug to cut off B+ to the output tube plate should the speaker be disconnected. On some models without field coil speakers, that left the screen of any tube with one (tetrodes, and beam pentodes), with a live screen grid. That meant that

the screen effectively became the plate, and, as it was not designed to handle plate current, it failed. In covering that likelihood; by cutting off all B+, the first [reservoir] capacitor is a 600v one, to resist the surge voltage, which will happen on switch-on.

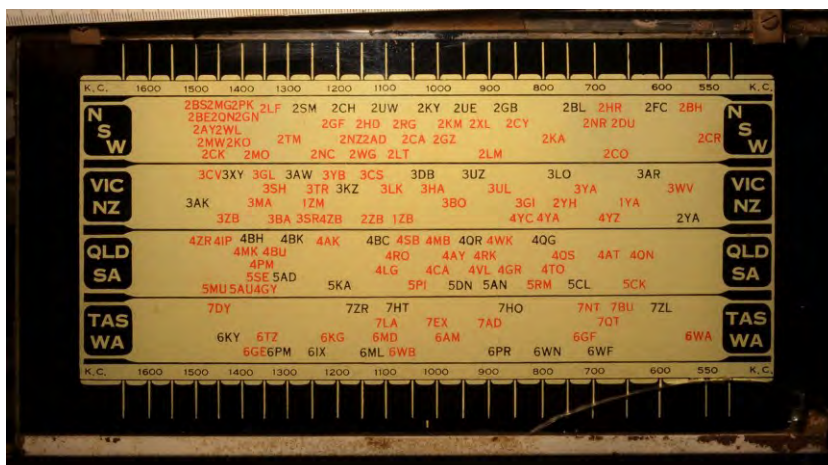
The dial bulbs were a 6v 5watt automotive types. While these were obtainable, the damage to the dial glass did suggest that they were running too hot. As both were blown, and the grommets they were mounted in had started to break up, I decided to change these to a lower wattage conventional type at closer to 2watts. I saved the old sockets, in case that did not work out. The glass was removed, mainly to get the grot out (photo, above).

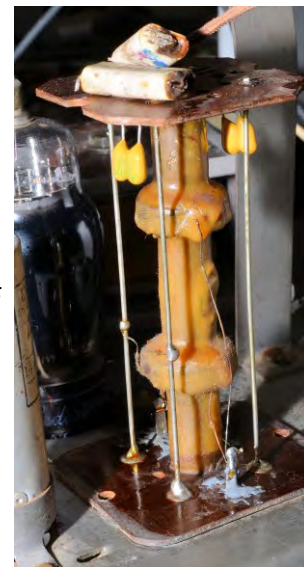
The NOS 6U7 tube was faulty with an unsoldered pin, on replacing with another tested one, I realised the socket was also broken, so out it came. Next came the realization the first IF transformer (photo, right) had a ‘make and break’ fault. That was a broken 100pF capacitor so I changed both. Now for the pentagrid....

This 6A8 is quoted as having good sensitivity on the Broadcast band and on the shortwave bands down to 25 metres where its sensitivity drops, rapidly falling off below 20 metres (‘RCA Handbook 1944’). Also, this tube type does not like AGC/AVC on shortwave, as this causes frequency shift, which is largely why it was superseded by tubes like the 6J8, with a separate triode for the local oscillator built-in. The B+ supply voltage was another problem, as the 6A8 tube’s oscillation is not very stable with variations in supply voltage. Its socket also turned out to be faulty. Naturally the socket pins on the new, did not line up with the old socket, requiring some rewiring.
